Anglesey Land Holdings

Prosperity Parc, Anglesey

**Geotechnical Interpretation and Design
Parameters Report**

HB Geotechnical Services

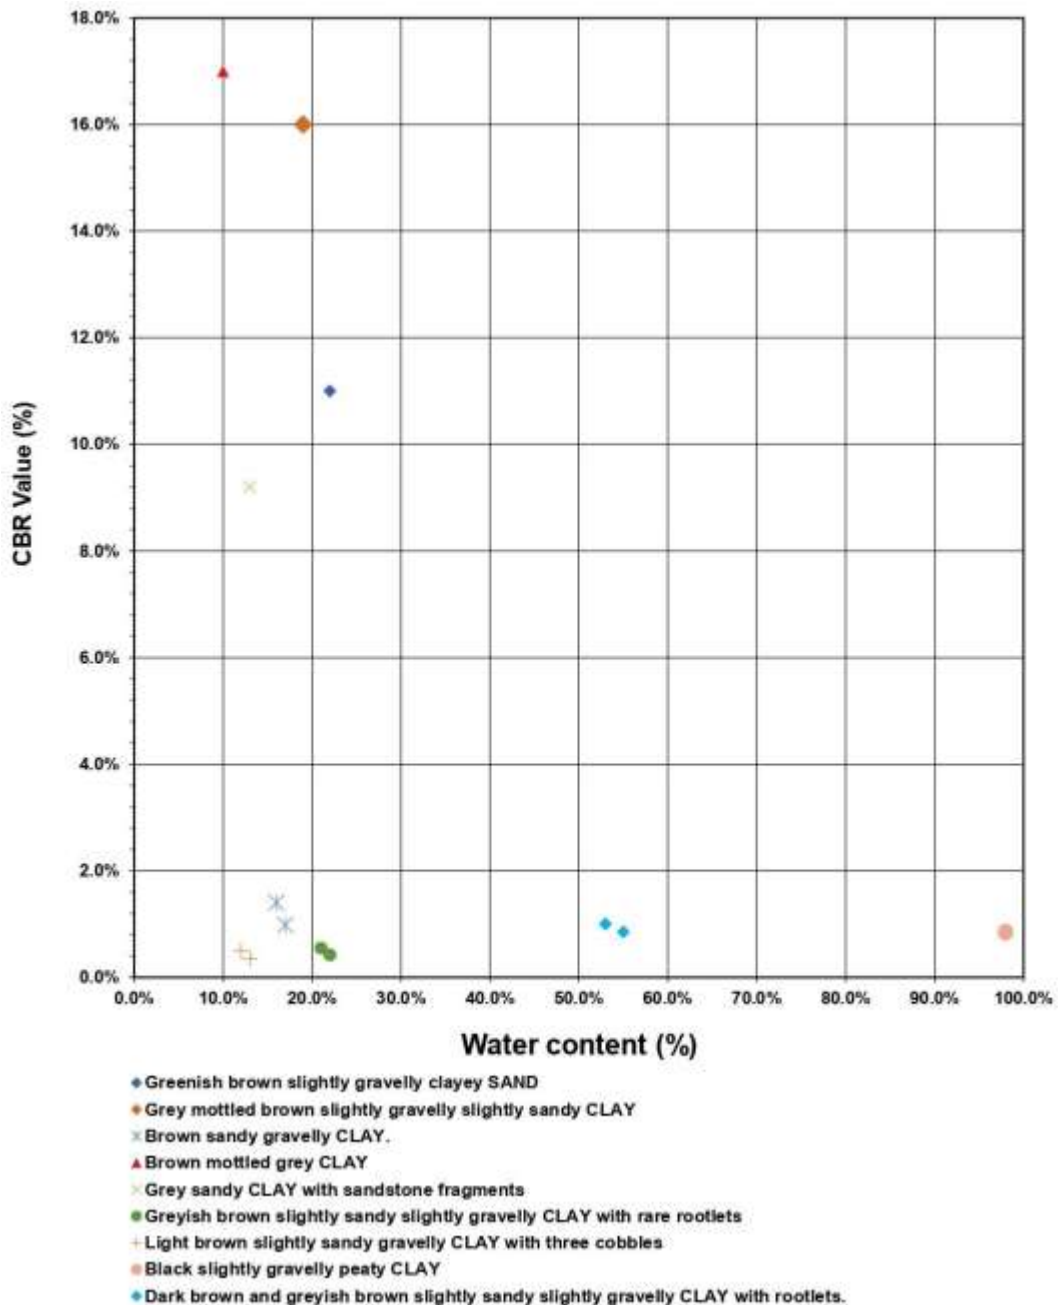
Figure 4: Results of Filed CBR tests

A total of around 150 CBR (California Bearing Ratio) tests were planned for trial pits along the proposed roadways and hardstandings. Among these, only 4 tests were actually conducted within the superficial granular material at depths between 0.55 and 0.75 meters. The CBR values from these tests ranged from 9.2% to 16%, with an average value of 11.5%. This indicates that the material tested is not suitable for pavement construction, and therefore, capping material will be necessary or other ground improvement measures.

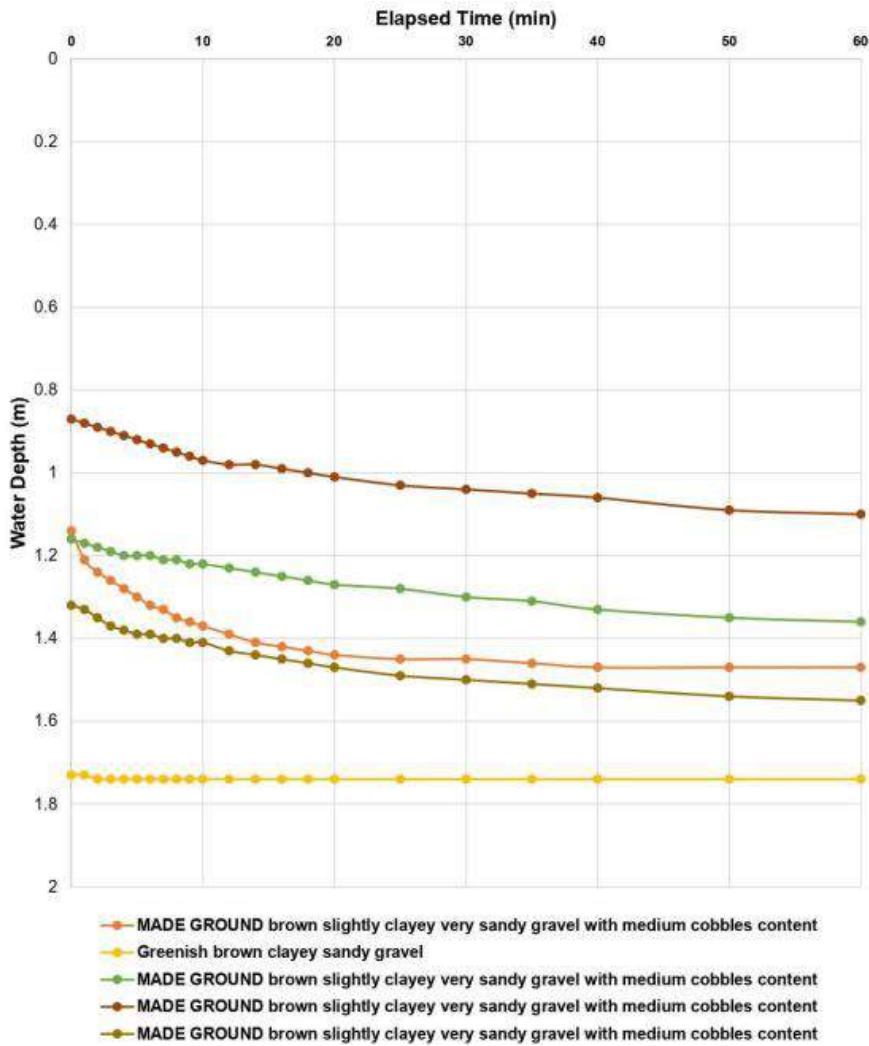
Figure 5: Results of soakaway tests

Five soakaway tests were conducted across the site. Three tests were performed within the made ground at locations 15, 141, and 252, while two tests were carried out within granular superficial deposits at locations 53 and 183. All tests indicated very limited soil infiltration, making it impossible to determine the permeability from these tests.

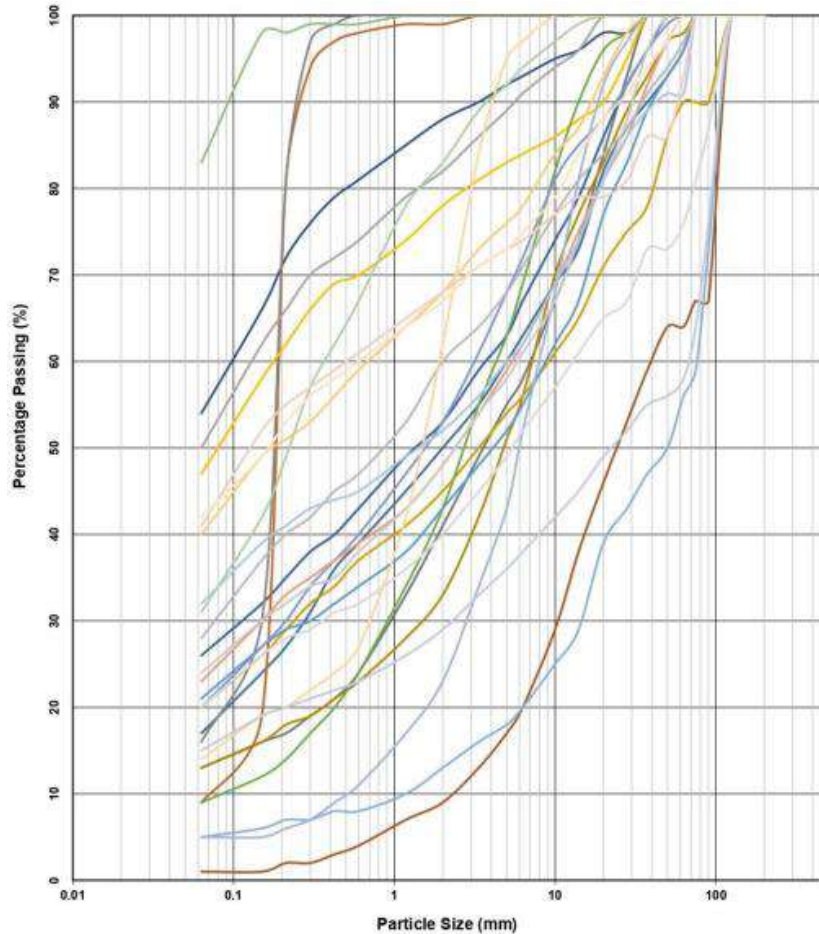
Figure 6: Particle Size Distribution Curves

Location (bh)	Depth (m)	Clay (%)	Silt (%)	Sand (%)	Gravel (%)	Cobbles (%)
Average Conveyor route		2.7	10.1	41.2	38.3	7.7
23 Reclamation yard	1.0	2	19	21	52	5
23 Reclamation yard	2.0	0	8	35	57	0
253 Reclamation yard	4.8	2	21	29	45	2
253 Reclamation yard	5.8	0	5	8	42	45
257 Reclamation yard	6.8	0	4	19	77	0
Average Reclamation yard		0.8	11.4	22.4	54.6	10.4
177 Wooded area	1.0	3	17	33	47	0
177 Wooded area	3.0	2	21	25	51	1
Average wooded area		2.5	19	29	49	0.5

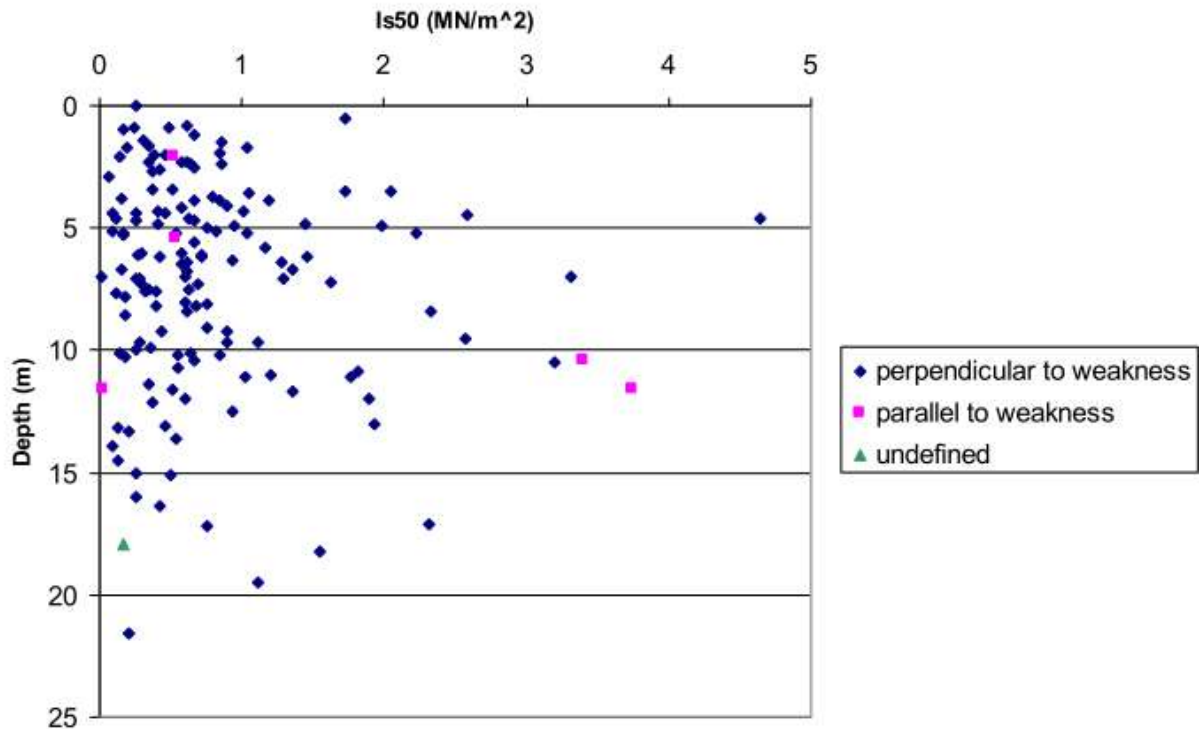
Figure 7: Results of Point Load Tests on Rock Specimens

The invalidated tests were caused by the rock fracturing along planes of weakness, generally oriented between 0 and 10 degrees, but occasionally at greater angles. All point load results were normalized for a 50mm diameter specimen (Is50). Figure 7 illustrates the scatter of diametral point loads against depth for the entire site. The normalized point load results show a seemingly random scatter with no clear relationship to depth.

Most results fall between 0.1 and 0.8 MN/m², with an average Is50 of 0.8 MN/m² when considering the entire range of results.

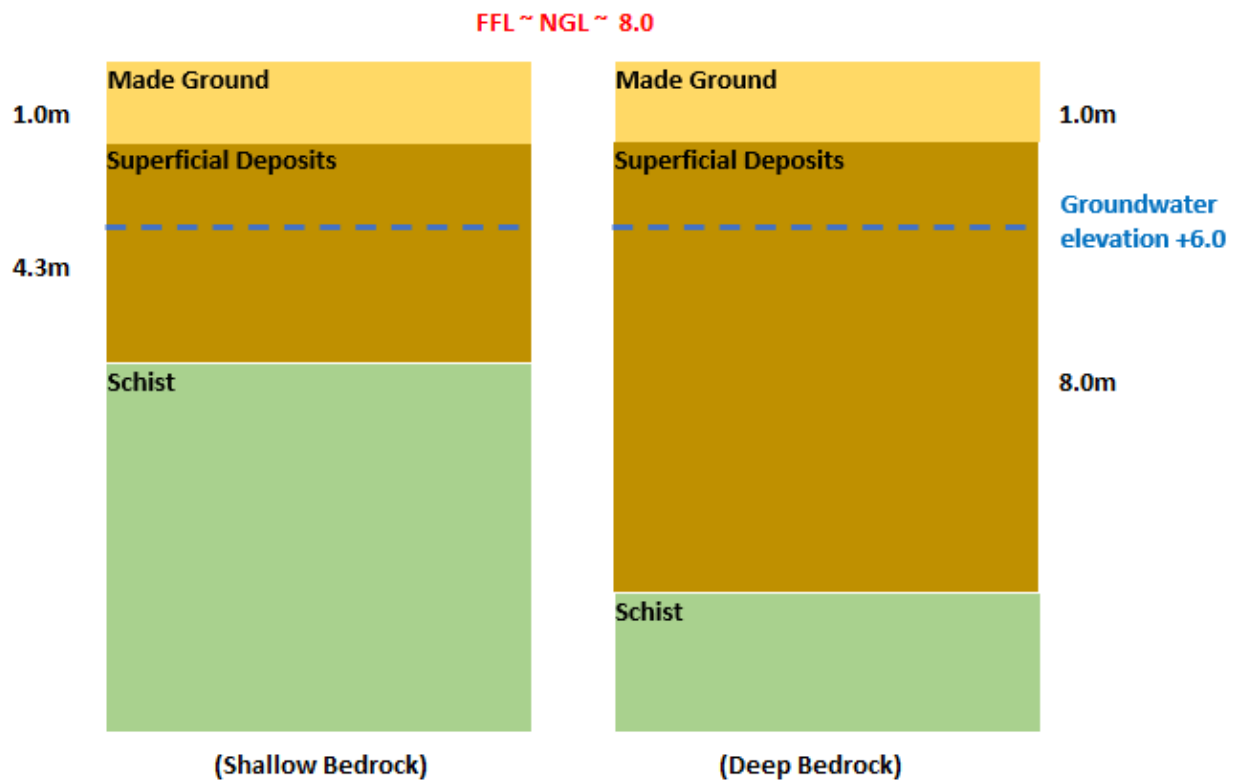
Figure 12: Ground model

The graphical representation of the ground model is depicted in the figure below.

In this figure, the superficial deposits can be either the superficial cohesive deposits or superficial granular deposits. The made ground layer in natural ground will be excavated and replaced by the Engineered Fill material in the final ground condition.

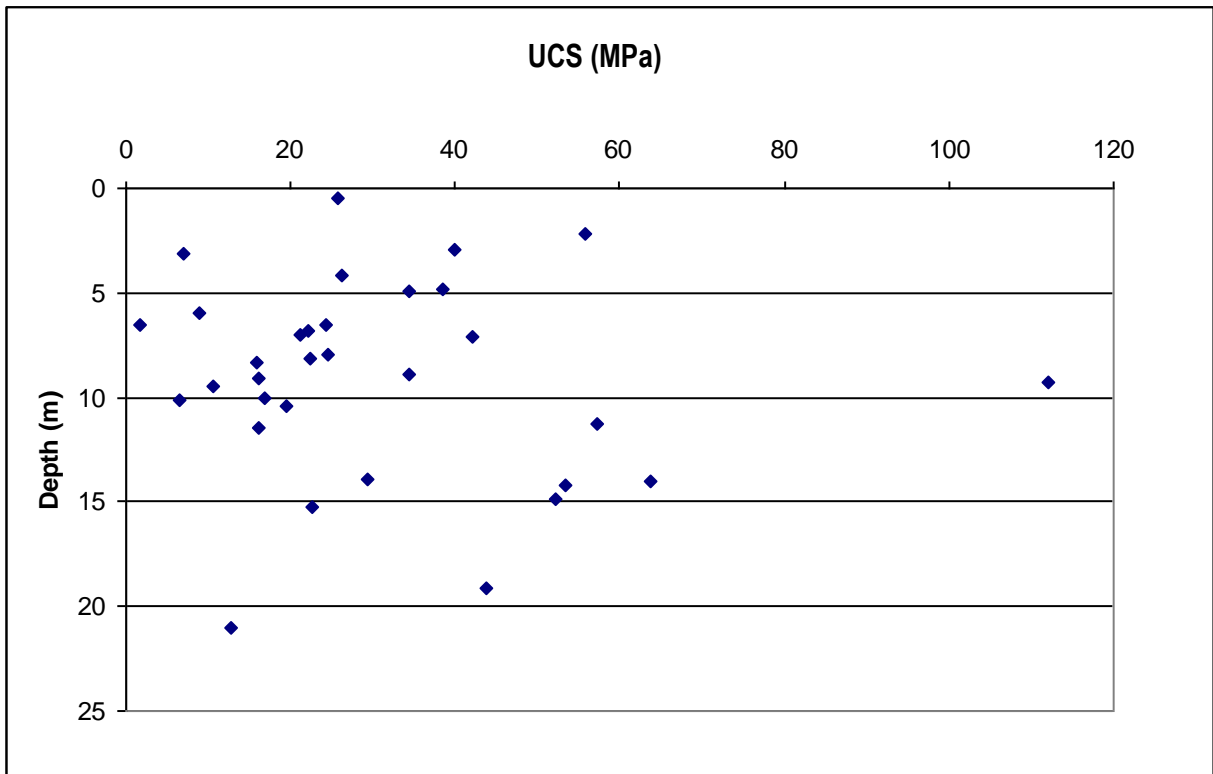
Figure 2.1.5: UCS results from 32 samples obtained from across the entire REP site

- A total of 32 Unconfined Compressive Strength (UCS) tests were performed on samples extracted from 26 boreholes, with 29 of these tests including measurements of Young's modulus and Poisson's ratio.
- The scatter plot in Figure 2.1.5 illustrates the distribution of UCS values with depth, showing the majority of results falling between 10 and 35 MPa, while the average UCS value was calculated at 30 MPa. However, outliers were notable, with a minimum UCS of 1.72 MPa and a maximum of 112 MPa.

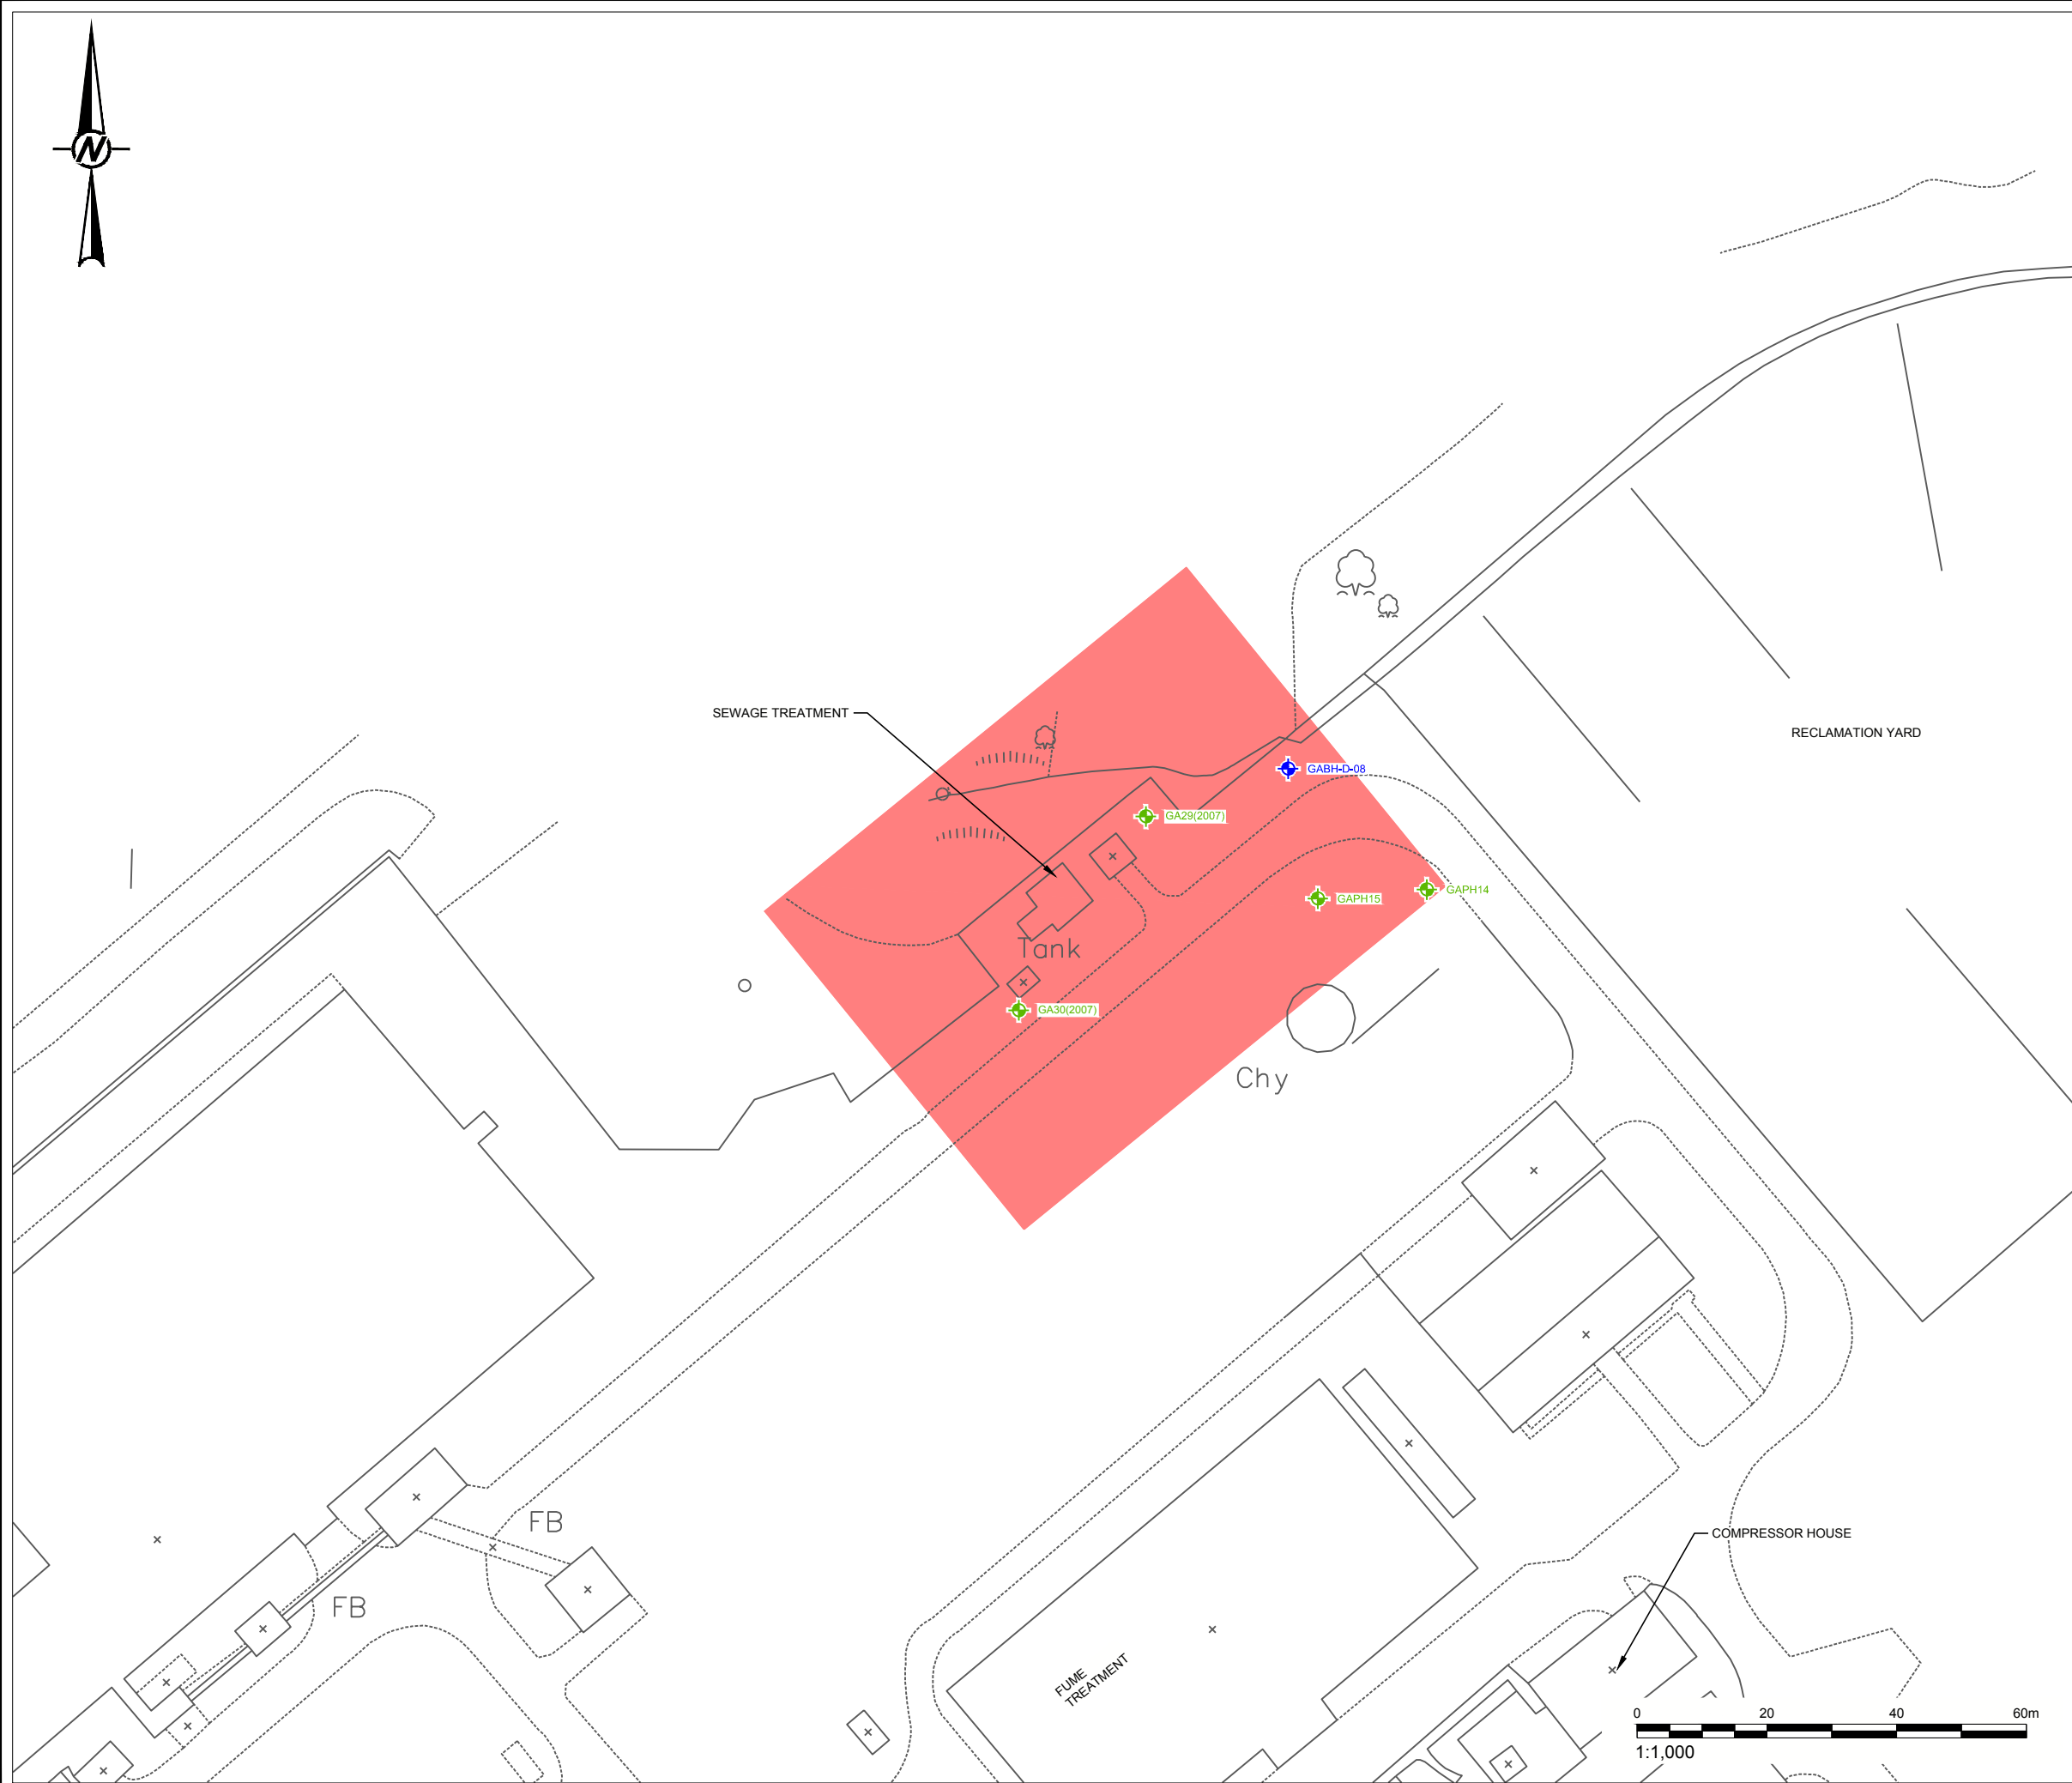
Rev	Description	PM	Review	Date
Client ANGLESEY ALUMINIUM				
Project PHASE C PERMIT SURRENDER REPORT				
Title SEWAGE TREATMENT PLANT LAYOUT AND INVESTIGATION LOCATION PLAN				
Created by	Requested by	Proj Manager	Reviewer	Date
TJ	RV	EDG	EDG	06/01/14
File No. 585455		Project No. 11514550169		
Size A3	Scale 1:1,000	Status REPORT ISSUE		
Drawing No. 7				Rev -

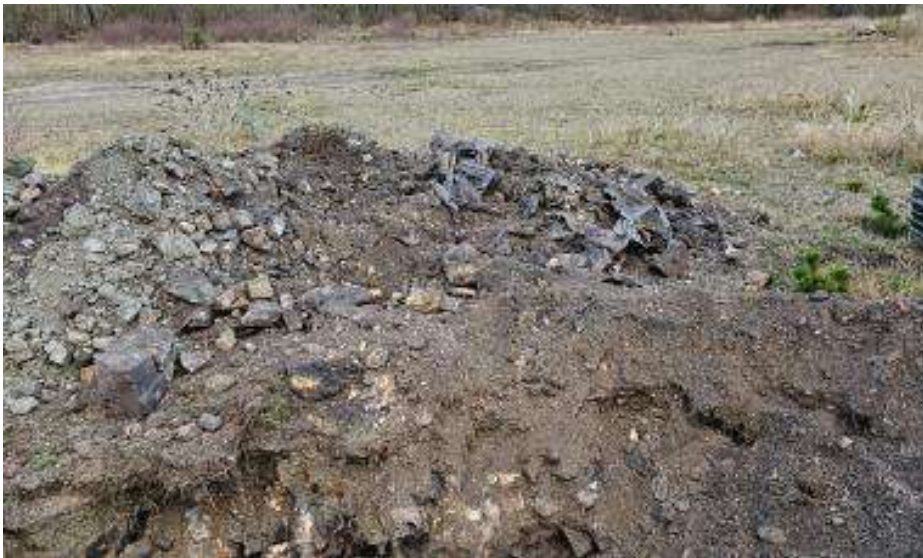
Plate 1

Typical examples of the Made Ground are shown on the following Plates (nos. 1, 2, 3 & 4) below.

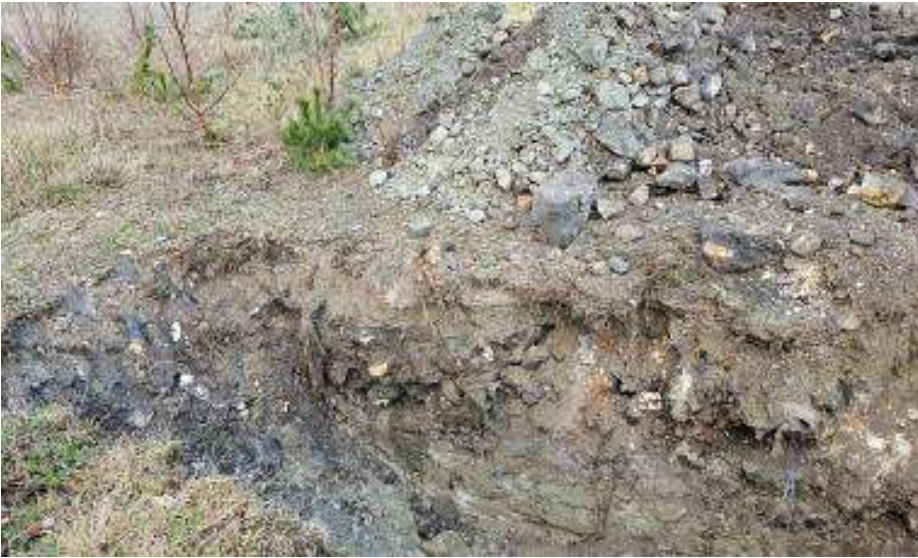
Plate 5

Typical examples of the Made Ground overlying Glacial Till deposits are shown on the following Plates (nos. 5 & 6) below.

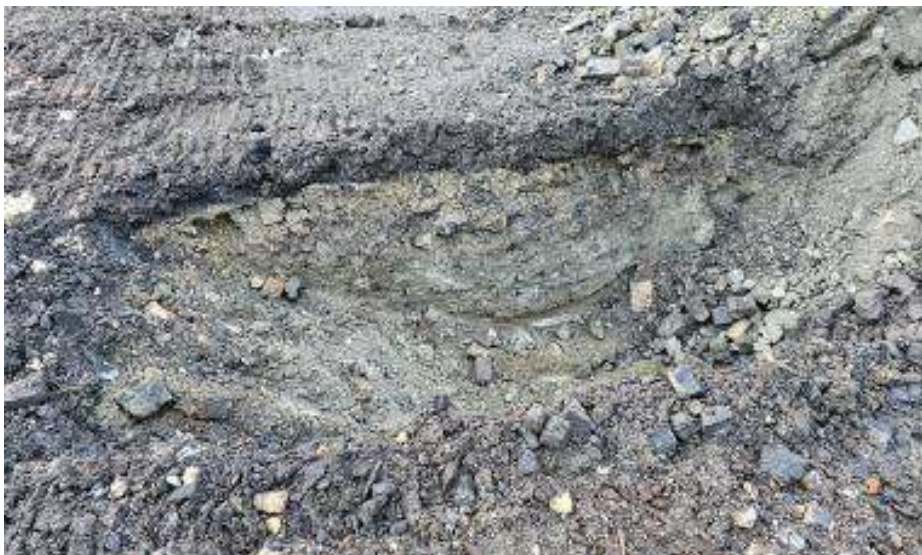
Plate 7

A typical example of the Glacial Till is shown on Plate no. 7 below.

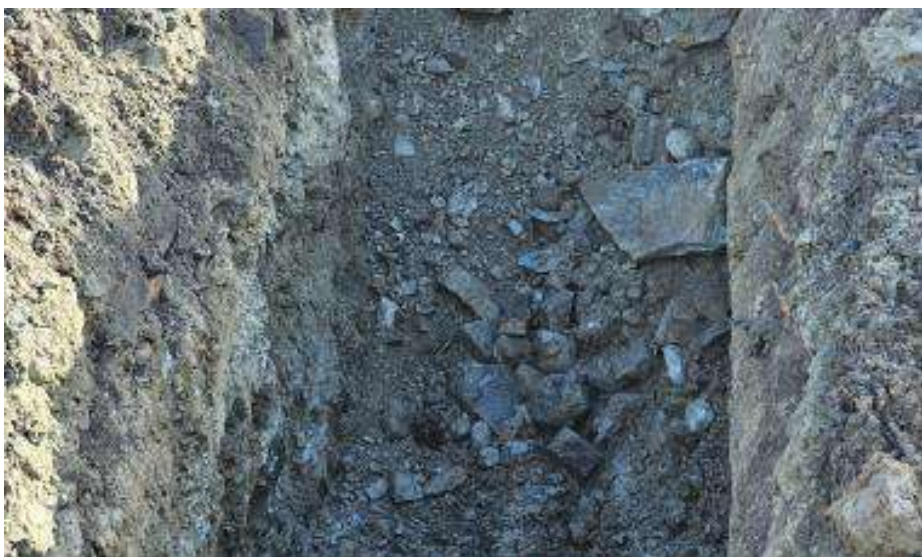
Plate 8

Typical examples of the Schist bedrock present near surface are shown on Plates (nos. 8 & 9) below.

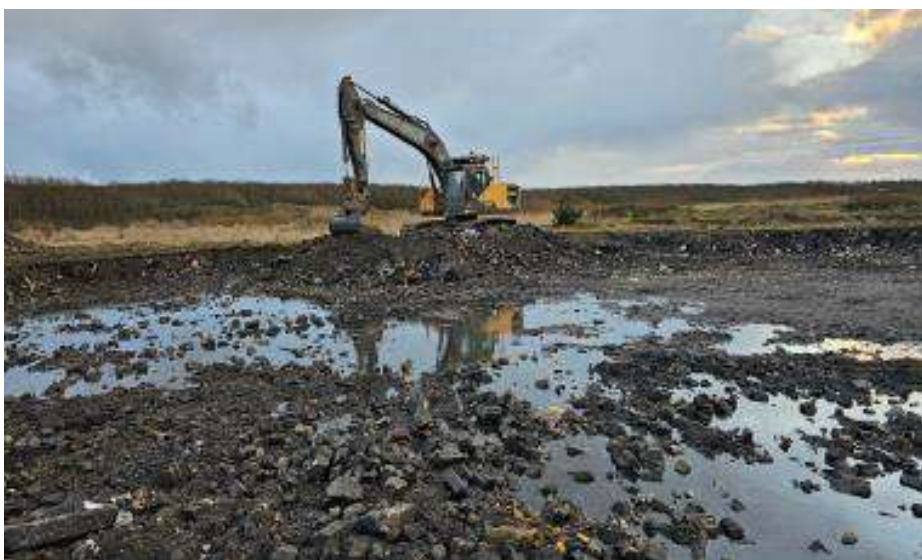
Plate 10

A typical example of the standing surface water is shown Plate no. 10 below.

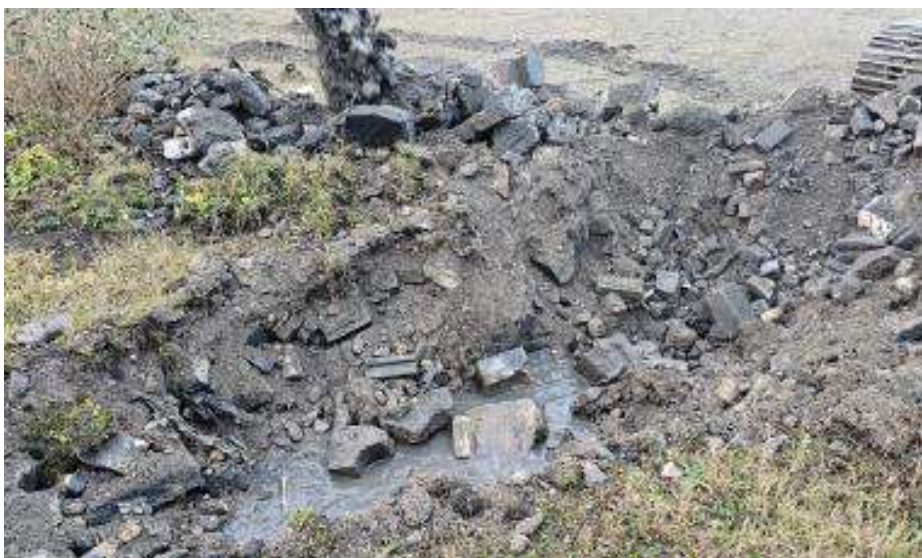
Plate 11

Typical examples of shallow groundwater ingress into trial pits from the Made Ground are shown on the following Plates (nos. 11, 12 & 13) below.

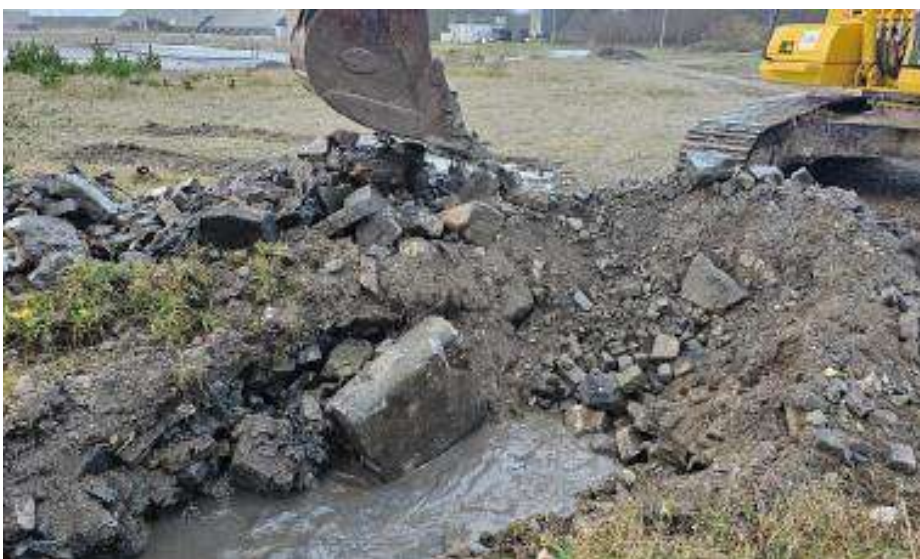
Plate 14

A typical example of the rapid groundwater ingress from the Made Ground into a trial pit is shown on Plate no. 14 below.

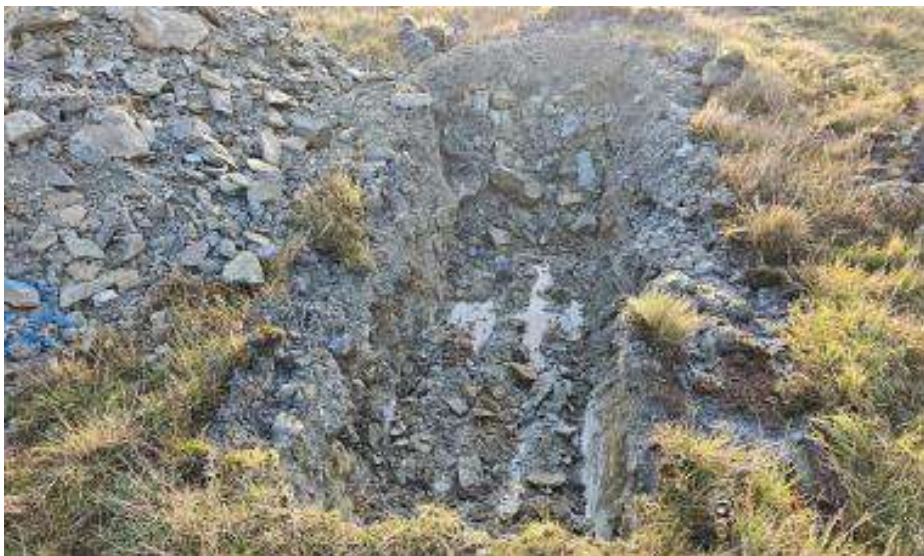
Plate 15

A typical example of the groundwater ingress from the Glacial Till / Schist bedrock interface is shown on Plate no. 15 below.

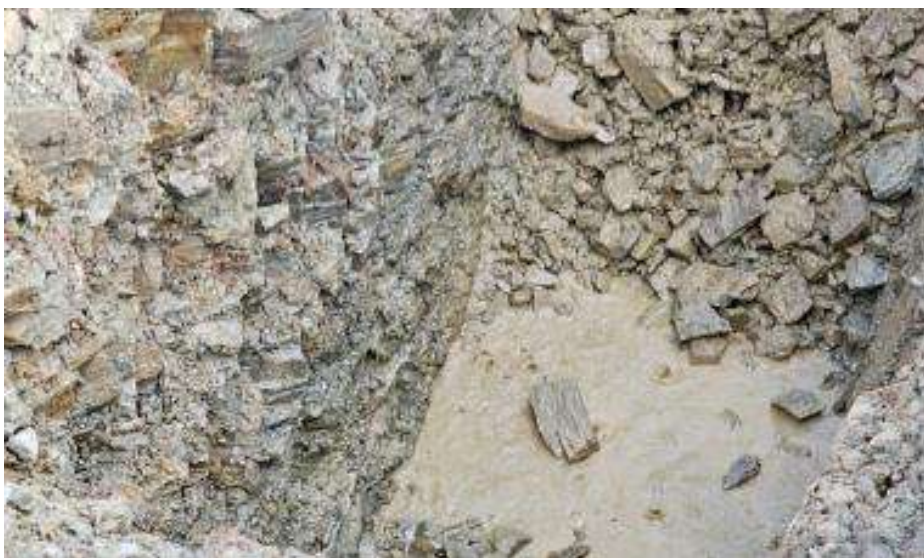
Plate 16

A typical example of the groundwater ingress from the near surface Schist bedrock is shown on Plate no. 16 below.
